Overview of the Quench Heater Performance for MQXF, the Nb₃Sn Low- β Quadrupole for the High Luminosity LHC

IEEE Transactions on Applied Superconductivity, 28(4)

S. Izquierdo Bermudez, G. Ambrosio, H. Bajas, N. Bourcey, G. Chlachidze, J. Ferradas Troitino, P. Ferracin, J. C. Perez, F-O. Pincot, E. Ravaioli, C. Santini, S. Stoynev, E. Todesco, G.L. Sabbi, G. Vallone

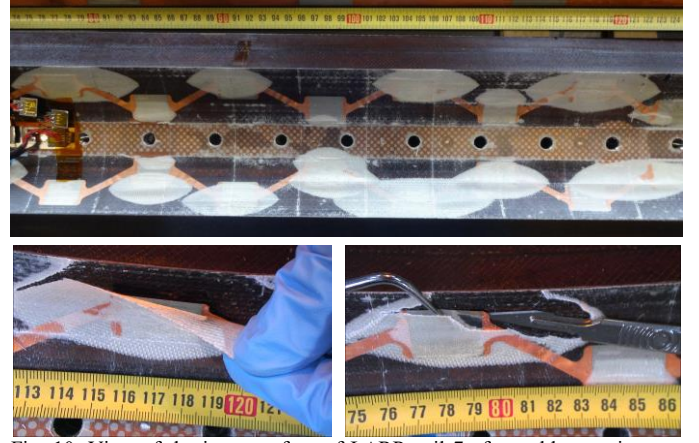
Fig. 10. View of the inner surface of LARP coil 7 after cold powering test (top). Example of the lack of adherence glass-epoxy to trace (left). Example of heater to polyimide delamination (right).

Whereas outer layer heaters operate under a compression force, supported by the collars, there is no pressure between the structure and the inner layer heaters. A series of modifications were implemented in the inner layer heater design in order to overcome the detachment of the heaters from the coil experienced in previous LARP magnets [8] (see section II). Despite the actions taken, Fig. 10 (top) shows the strong signs of delamination (“bubbles”) on the inner coil diameter after powering test. Detachments were observed on all the coils, mostly located on the heater stations. Destructive inspection of LARP coil 7 revealed that the source of the problem is the epoxy to metal adherence and not the gluing of the trace to the coil turns, as it can be seen in Fig. 10, left. Heater to polyimide delamination (see Fig. 10, right) was only present in three out of the 38 heater stations in coil 7.

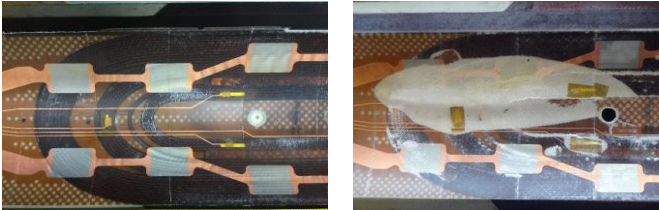
Fig. 12. LARP coil 7 before (left) and after (right) cold powering test.

The bubbles are not only over the heater stations, but also in the coil ends. Figure 12 shows a view of the inner surface of LARP coil 7 before and after cold powering test. In order to study the bubble formation in absence of inner layer quench heaters, a coil where the trace is not installed in the inner
